ECLIPSE
Engineering Bulletin
No: EB-0402

Product : Series 50 Receivers and Transmitters

Topic : Irregular Power Supply Reset

Date : 30th September 2004

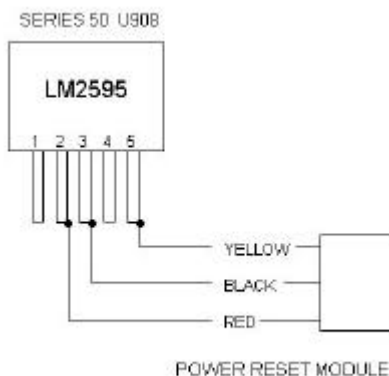
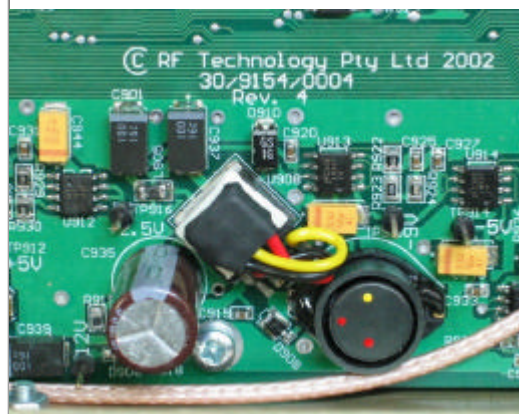
Symptom: In some circumstances the front panel PWR LED does not light up when the power supply is switched on, especially when the SMPS28 is switched off and on in quick succession.

Fix: A Power Reset Module (PRM) has been developed to ensure that the regulator U908 turns on reliably. The PRM is supplied ready made with a self adhesive tape backing and 3 fly leads which are Yellow, Red and Black in colour.

To install the PRM firstly remove DC power from the receiver or transmitter. Locate U908 LM2595 regulator near the bottom edge central mounting screw. Solder the coloured fly leads to the LM2595 as per diagram, remove the protective layer on the adhesive backing and press mount the PRM directly on to U908.

With the PRM installed the PWR LED should turn on and off reliably.
