# Engineering Bulletin

**ECLIPSE**  
**Engineering Bulletin**  
No: EB-0405

**Product : Eclipse Exciter**

**Topic : Substrate Crack found in Mitsubishi RF Power modules**

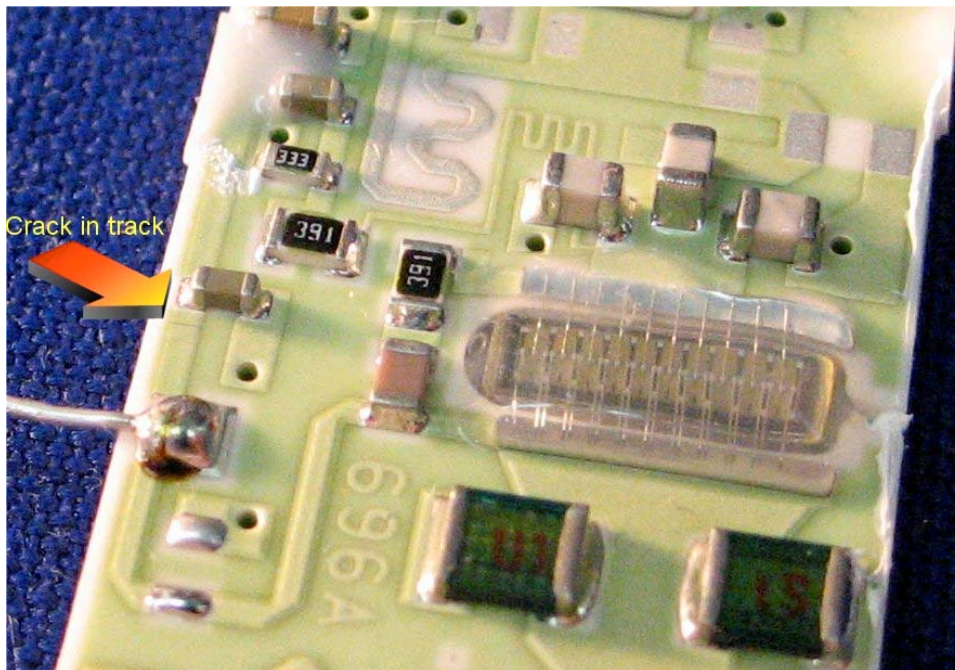
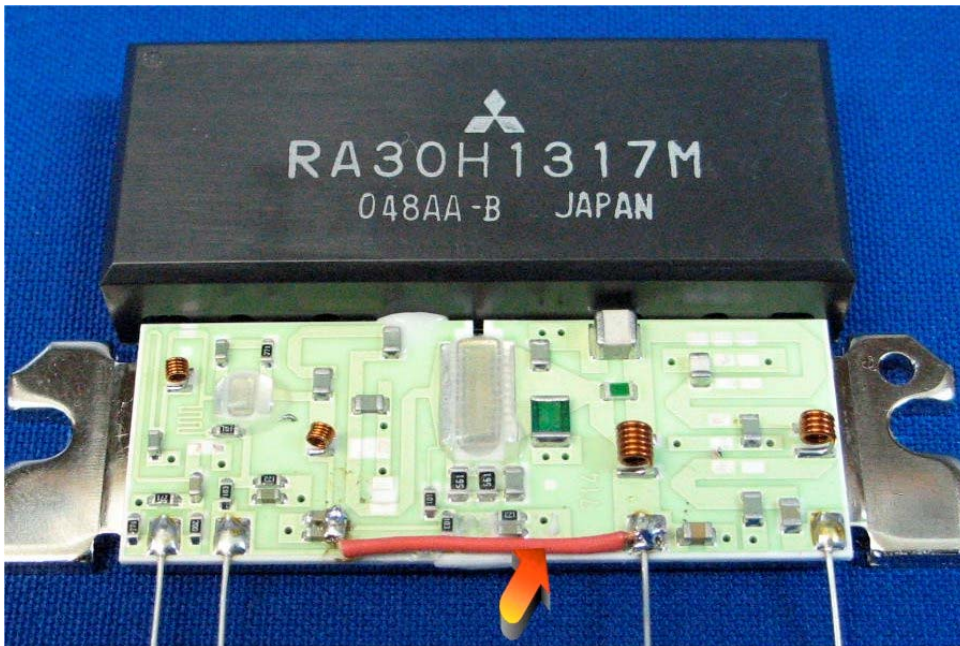
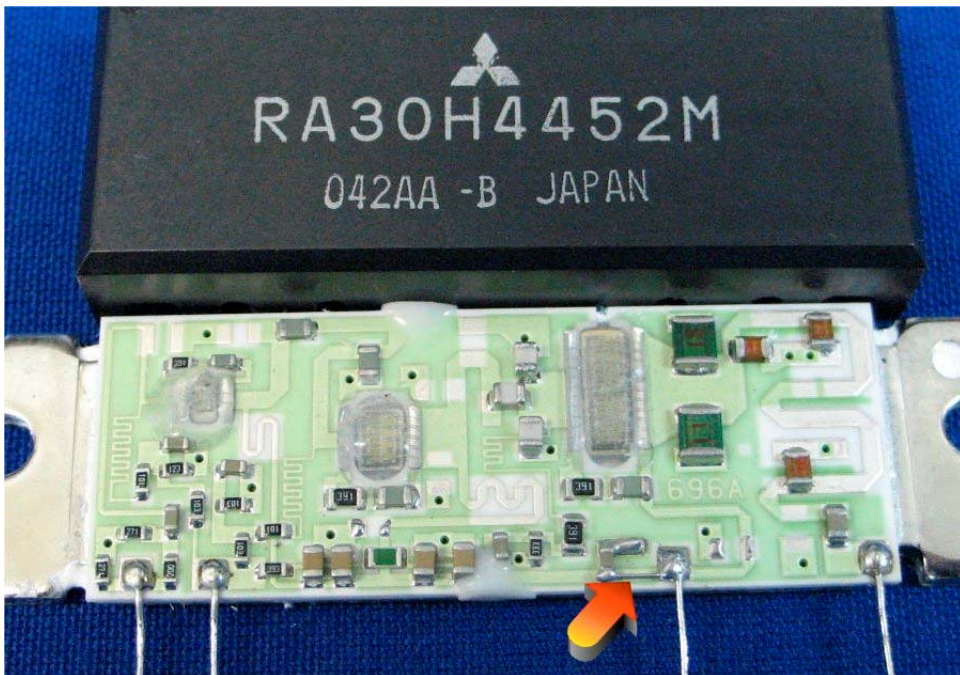
There have been recent reports of some faulty Mitsubishi modules in the field. The symptom is the exciter has no output power. The power supply track was broken inside the Mitsubishi RF power module due to the substrate cracked under some rapid temperature-changing situation.

If you find any faulty exciter of this symptom, please contact RF Technology for power module replacement. We currently fix this problem by connecting an additional wire to ensure the crack will not affect normal operation of the module.
