Engineering Bulletin

ECLIPSE
Engineering Bulletin
No: EB-0501

Product : STG-1

Topic : C19 polarity in 9169/0002 PCB assembly

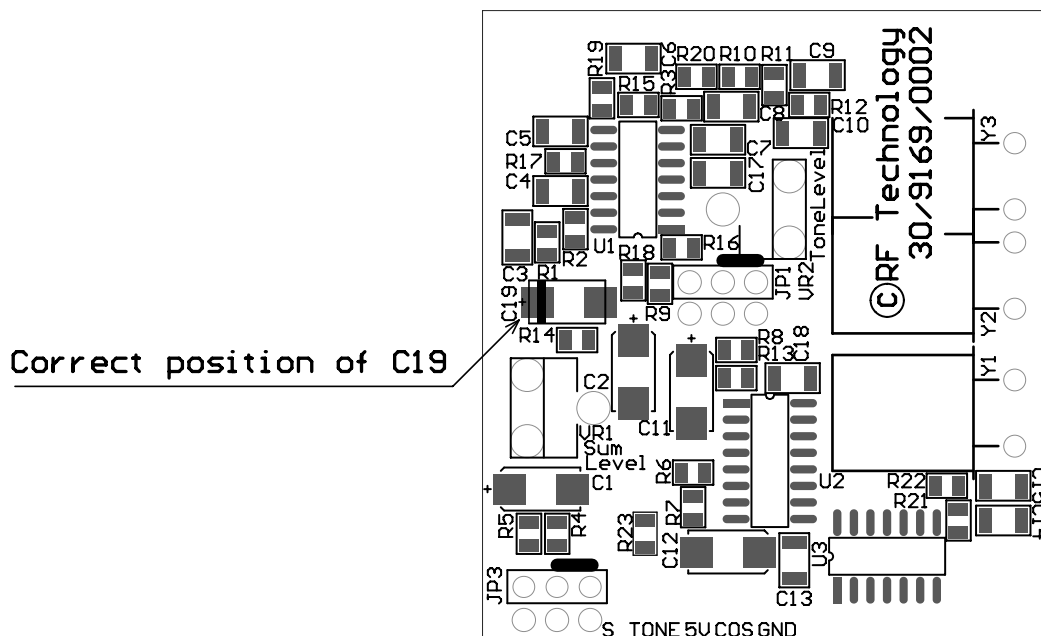
In revision 2 of RF Technology's STG-1 (Status Tone Generator) module, the position of 10uF electrolytic capacitor, C19 was reversed on PCB. It causes distortion at the receiver line/direct audio output.

The affected module can be identified by the PCB version number: 30/9169/0002. If audio distortion problem was found with STG-1 module, check the position of C19, refer following diagram to fix the problem. Note the bar marking (positive) is closest to the PCB edge.
