***ECLIPSE***  
**Engineering Bulletin**  
No: EB-0502

**Product : 9150(9176) DCS/CTCSS MODULE**

**Topic : Firmware Update**

**Date : 14/09/2005**

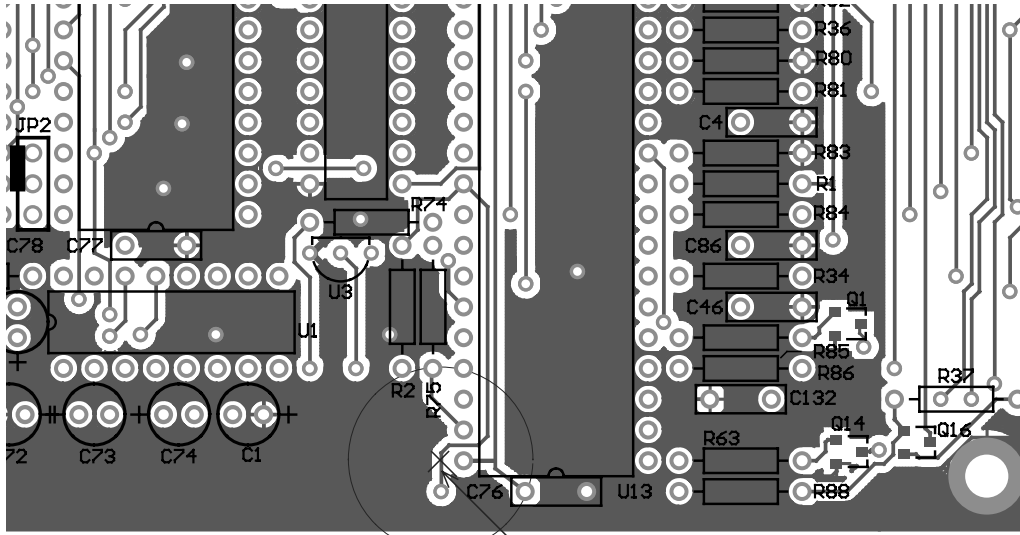
Top Layer of TX PCB

Cut the track here

Replace the EPROM with revision 059103V12 (supplied by RF Technology)  
Further modifications on the TX PCB are needed, refer EB0404.

1. Cut the track (schematic diagram net name "reset") as shown.
2. Connect U13 Pin44 (MISO) to the Via hole (pin3 of the sub tone module)

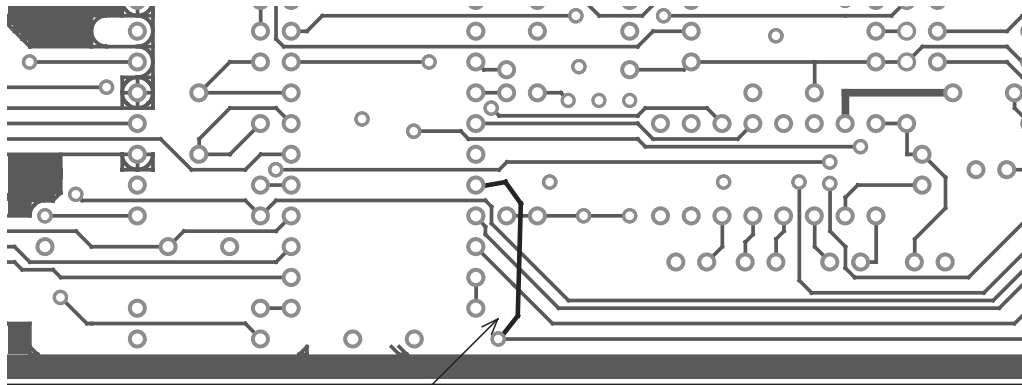
Bottom layer of TX PCB

Connect Via hole to U13 Pin44
